Westfield, NJ

Pavement Management Analysis Report

December 2019

IMS
Infrastructure Management Services

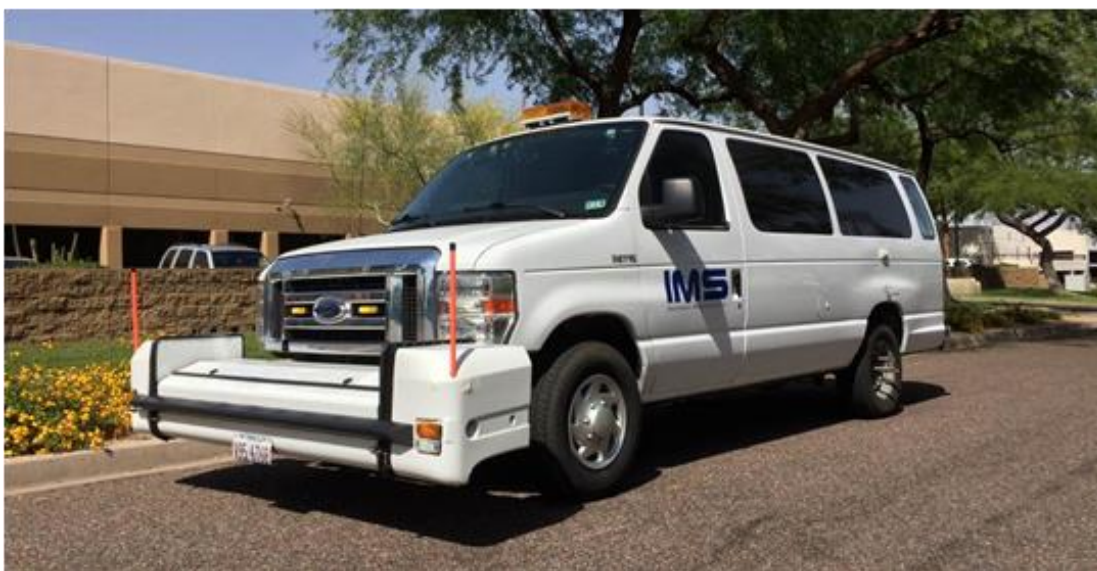
Figure 4 – Laser Road Surface Tester (RST)

Following a set of predefined assessment protocols matching the pavement management software (ASTM D6433), a specialized piece of survey equipment – referred to as a Laser Road Surface Tester (Laser RST, pictured on page 5) – is used to collect observations on the condition of the pavement surface, as well as collect high definition digital imagery and spatial coordinate information. The Laser RST surveys each local street from end to end in a single pass, while all other roadway classifications are completed in two passes.

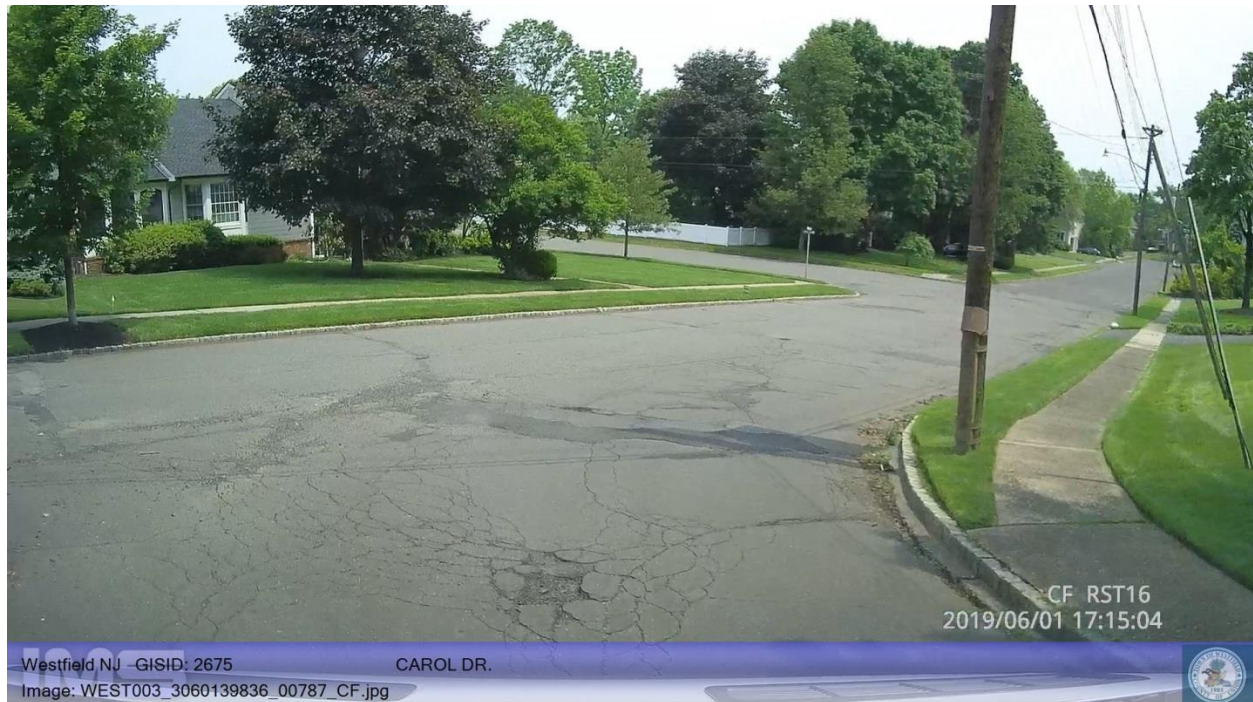
Carol Drive from Golf Edge to Lynn Lane (GISID 2675, PCI = 23) – Rated as Very Poor, this street displays spreading base failure as evidenced by the severe alligator cracking, patching and potholes. A mill and overlay on this street would not be suitable as the base has failed and would not meet an extended service life of at least 15 years. This street requires a full reconstruction and should be carefully monitored.

Deferral of reconstruction of streets rated as Very Poor will not cause a substantial decrease in pavement quality as the streets have passed the opportunity for overlay-based strategies. Due to the high cost of reconstruction, Very Poor streets are often deferred until full funding is available in favor of completing more streets that can be rehabilitated at lower costs, resulting in a greater net benefit to the Town. This strategy however must be sensitive to citizen complaints forcing the street to be selected earlier. It is important to consistently monitor these streets and check for potholes or other structural deficiencies until the street is eventually rebuilt.

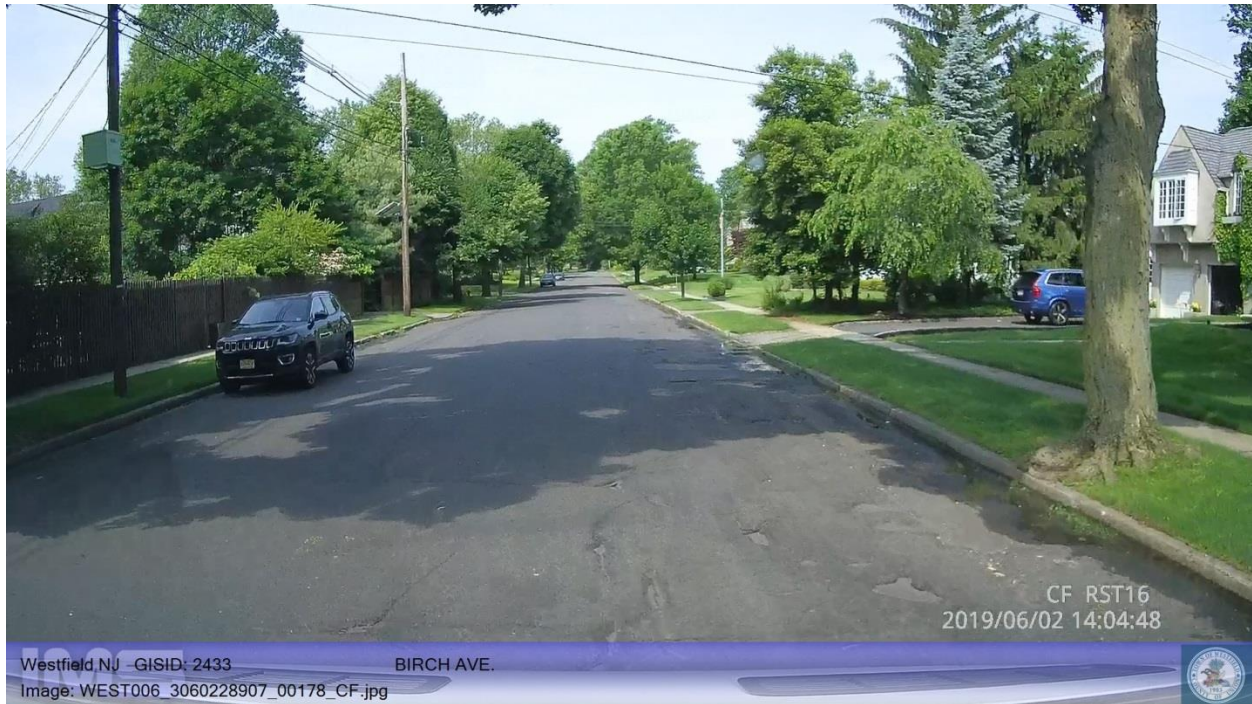
Birch Avenue from Standish Avenue to Mountain Avenue (GISID 2433, PCI = 34) – Rated as Poor, this segment still has some remaining life before it becomes a critical reconstruction need. As evident in the imagery, the existence of multiple potholes on this segment severely impacts the PCI score of the entire segment. On this street, the base is showing signs of failure in areas exhibiting severe raveling. The severely cracked areas are isolated and do not persist throughout the entire segment length and cross section. These areas should be dug out and structurally patched to attain the maximum life from any potential rehabilitation efforts. If left untreated, within a short period of time, a full reconstruction would be required.

On arterial roadways, Poor streets often require partial to full reconstruction – that is removal of the pavement surface and base down to the subgrade and rebuilding from there. On local roadways, they require removal of the pavement surface through grinding or excavation, base repairs, restoration of the curb line and drainage, and then placement of a new surface.

In general, the service life of Poor streets is such that if deferred for too long, it would require a more costly reconstruction. Streets rated as Poor are typically selected first for rehabilitation as they provide the greatest cost/benefit to the Town – that is the greatest increase in life per rehabilitation dollar spent.

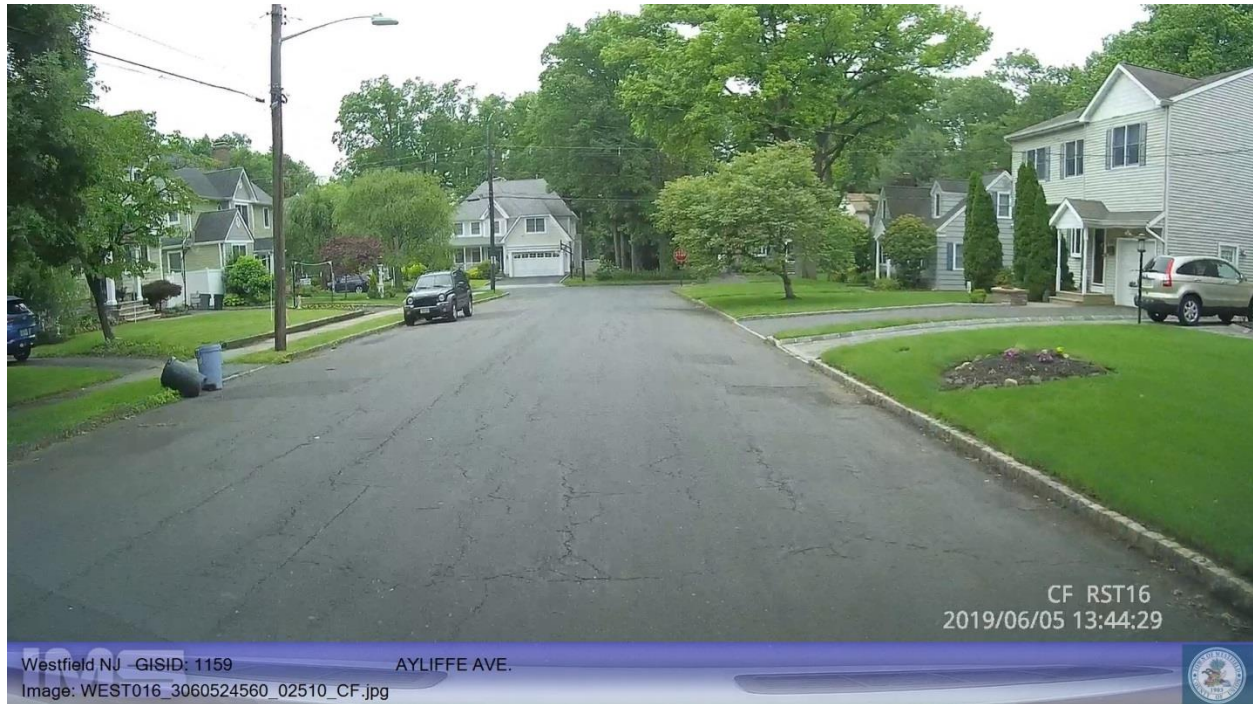
Ayliffe Avenue from Summit Avenue to Boulevard (GISID 1159, PCI = 43) – Rated as marginal with a PCI score at the lower range between Marginal and Poor streets. Marginal streets have distresses that tend to be localized and moderate in nature – that is they do not extend the full length of the segment and can be readily dug out and repaired. This street segment highlights this characteristic as the failed area does not quite extend the full length or width of the roadway and is still serviceable. However, it also highlights the relationship between base and pavement quality. Placing an overlay on this street without repairing the base would not achieve a full 15 year life as the failure would continue to occur over time. Structural patching of the failed areas along localized rehabs would permit a full width grind and inlay on this street segment and return it to full service. The curb lines are straight and drainage is functioning well.

Marginal streets that display high amounts of load associated distresses are selected as a priority for rehabilitation as they provide the greatest cost/benefit to the Town. If left untreated, Marginal streets with high amounts of load associated distresses would deteriorate to become partial reconstruction candidates. Marginal streets that are failing due to materials issues or non-load associated failures may become suitable candidates for thick overlays if deferred, without a significant cost increase.

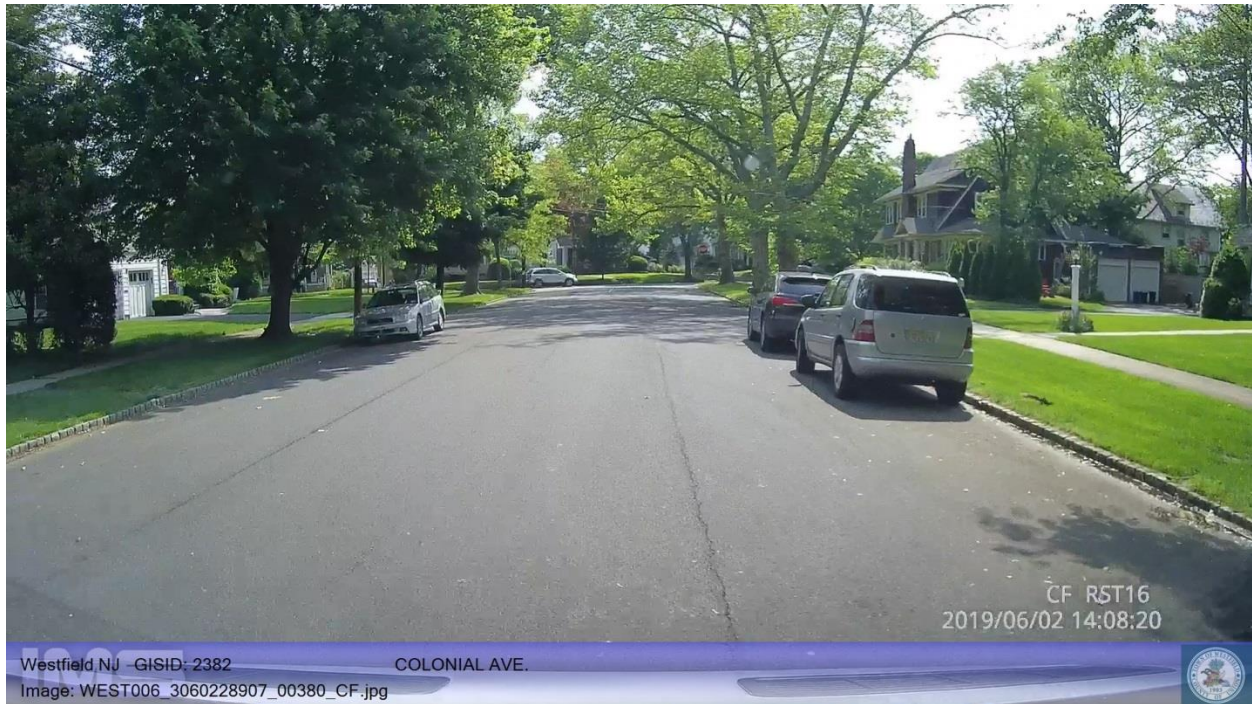
Colonial Avenue from Standish Avenue to Mountain Avenue (GISID 2328, PCI = 61) – Rated as Good with the primary cause of deterioration longitudinal cracking. It also displays small amounts of load associated distresses that can easily be removed to restore the visual appearance of the roadway. The existing cracks should be sealed and the pavement surface restored, with a heavier surface treatment such as microsurfacing or double slurry to fully waterproof the pavement and cover the crack sealant. The occasional dig out and replacement may be required to correct localized deficiencies. Alternatively, depending on the extent of the distressed areas, base strength and drainage, a thin overlay may be applied.

Asphalt streets rated as Good are ideal candidates for thinner surface-based rehabilitations and local repairs. Depending on the amount of localized failures, a thin edge mill and overlay, or possibly a surface treatment, would be a suitable rehabilitation strategy for streets rated as Good. Streets that fall in the high

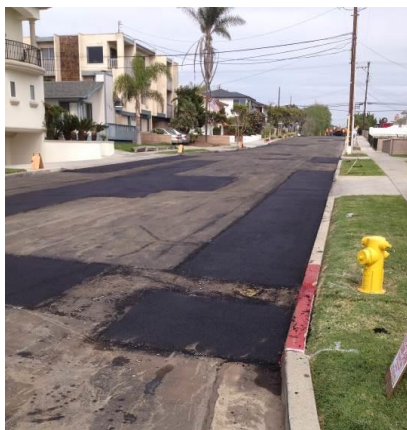
60 - low 70 PCI range provide the greatest opportunity for extending pavement life at the lowest possible cost, thus applying the principles of the perpetual life cycle approach to pavement maintenance. The adjacent photo is a great example of a street segment (not a Westfield Road) that displayed low load associated distresses and thus, high structural characteristics, and once the distressed areas were replaced, a slurry seal was applied. The patching accounted for less than 5 to 10% of the total area and resulted in a good looking, watertight final surface at a much lower cost than an overlay with less disruption to the neighborhood and curb line. The patches were paver laid and roller compacted.

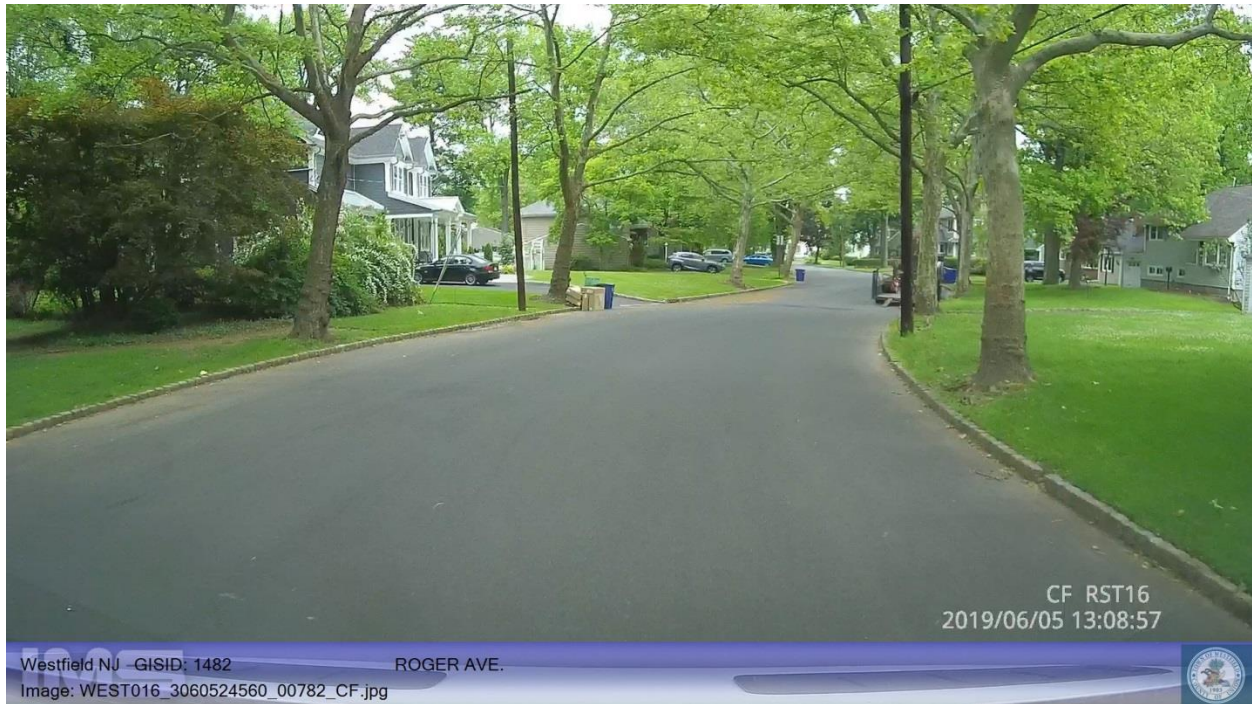
Roger Avenue from Grandview Avenue to City Limit (GISID 1482, PCI = 85) – Rated as Excellent, displaying little to no surface distresses. The ride is smooth and the surface is non-weathered and the base is strong. In a couple of years, this street segment would be an ideal candidate for routine maintenance activities such as crack sealant rehabilitation.
